Manhole Inspection Summary

Manhole # S09AA2032MH

Location Address: **5818 PIMILICO RD** Cross Street: **ROCKWOOD ST**

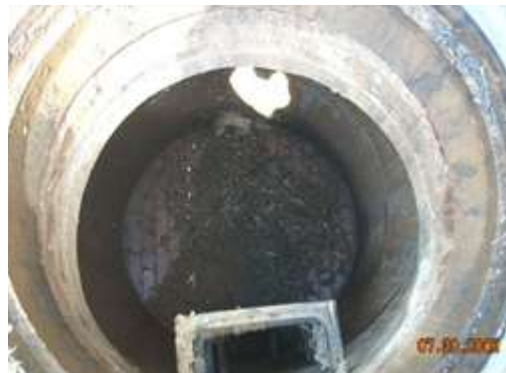
Top View

Channel debris.

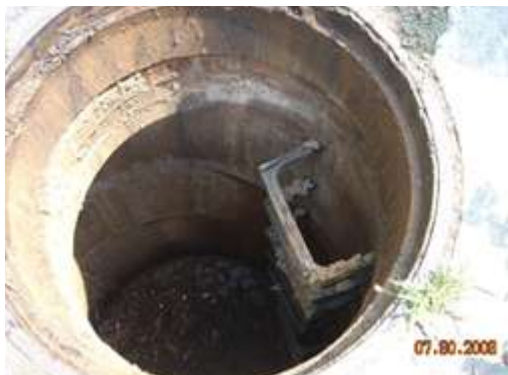
Defect

Frame Offset: **0** (in.) Condition: ☐ Sound ☐ Cracked ☒ **Leaks**

Chimney / Frame Adjustment ☒ Exists Material: **Brick** ☐ Parged Height: **11** (in.)
Condition: ☐ Sound ☐ Cracked ☐ Root Intrusion ☐ Loose Brick ☒ **Deteriorated**
Infiltration: ☐ None ☒ **Joint** ☐ Cracks ☒ **Mortar** ☐ Roots ☐ Wall

Corbel Material: **Precast Concrete** ☐ Parged Type: **Concentric/Eccentric**
Condition: ☒ Sound ☐ Cracked ☐ Root Intrusion ☐ Loose Brick ☐ Deteriorated
Infiltration: ☐ None ☒ **Joint** ☐ Cracks ☐ Mortar ☐ Roots ☒ **Wall**

Barrel Material: **Precast Concrete** ☐ Parged
Shape: **Circular** Diameter: **48** (in.) Length: (in.)
Condition: ☒ Sound ☐ Cracked ☐ Root Intrusion ☐ Loose Brick ☐ Deteriorated
Infiltration: ☐ None ☒ **Joint** ☐ Cracks ☐ Mortar ☐ Roots ☒ **Wall**

Frame leaks. Adjustment deterioration and infiltration. Corbel and Barrel infiltration.

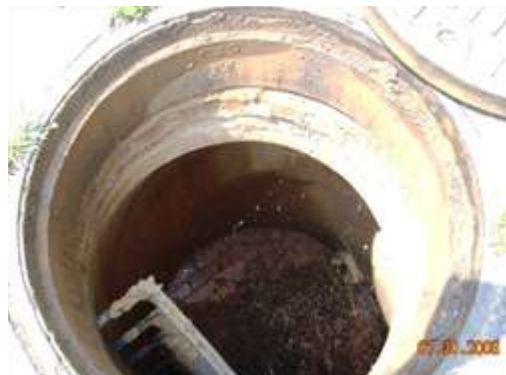
Defect

Frame leaks. Adjustment deterioration and infiltration. Corbel and Barrel infiltration - other side.
